*By AE2 Morgan Furlow*

# I Was a Half-Inch From

# m Death

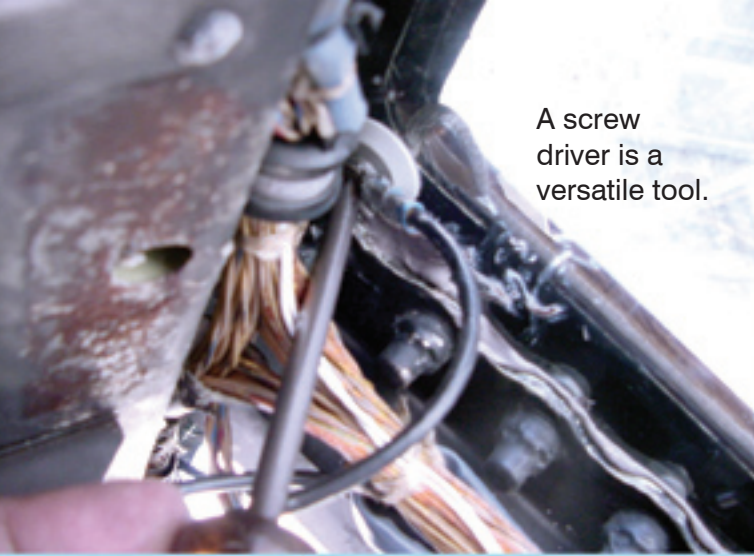
A screw driver is a versatile tool.

I was surprised to say the least. Aircraft power had shut down because of a system overload, and I noticed the scent of burnt metal in the air, reminding me of my high-school welding class. I examined the tool and found that about one-third inch of the screwdriver's tip had melted off.

I took a few seconds to calm my nerves and then checked the aircraft for damage. I found the piece of missing screwdriver had melted onto the head of the screw. With no further damage, I secured aircraft power and went to tell my LPO what had happened.
